## DEERING RESERVOIR DAM

NH 00282

### PHASE I INSPECTION REPORT NATIONAL DAM INSPECTION PROGRAM

NOVEMBER 1978

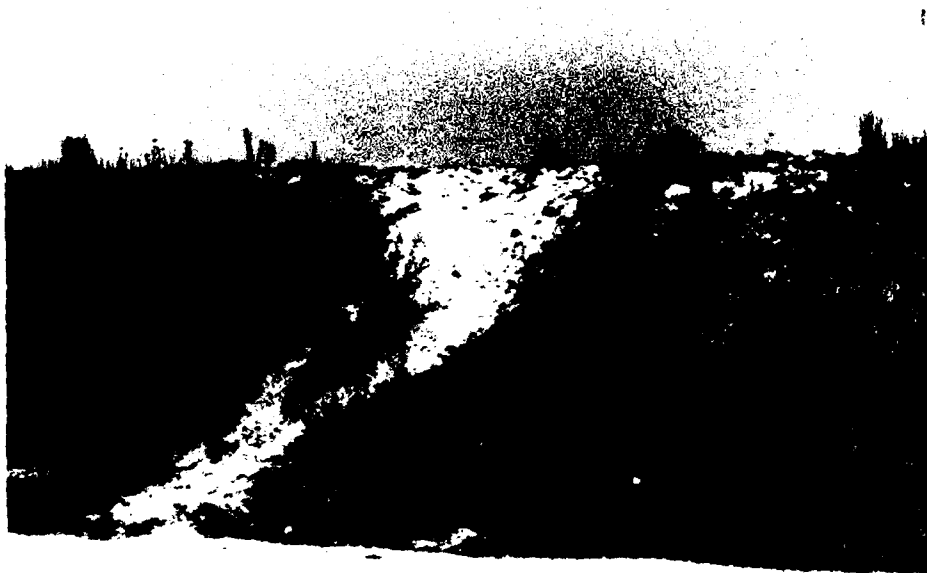
The slope is in generally good condition. In some areas the turf and grass cover is not as dense as it should be, and there is some minor erosion of the slope due to trespassing on the slopes. This erosion can be seen in Photos 5 and 6. Near the right abutment there is an area of dense undergrowth and trees. In general, the trees are below the dam slope. Personnel from the New Hampshire Water Resources Board indicated that they had planned to clean this area of excessive growth.

Photo No. 5 - Erosion of downstream slope.

(a) Repair and seed all surface erosion on the downstream face of the dam.

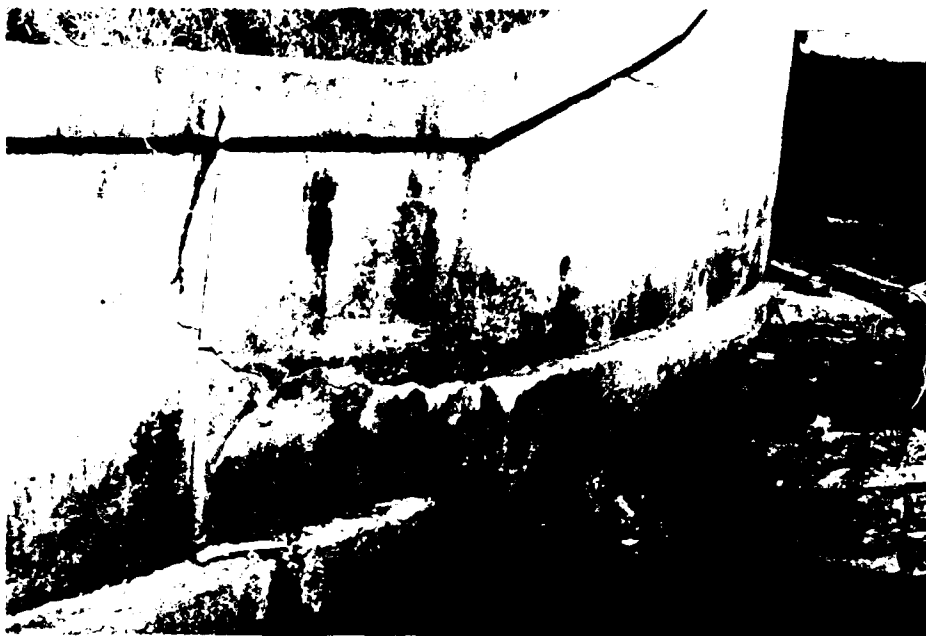
c. Appurtenant Structures. Visual inspection of the spillway structure showed the concrete surface and the two construction joints to be in generally good condition. There is, however, some erosion of the concrete joints. Photo 9 shows the general view of the spillway structure, with details of joint deterioration being shown on Photo 11.

The right training wall of the spillway is badly cracked. The extent of the cracking can be seen in Photos 10, 11, 12 and 13. Construction plans indicate that the gravity training walls were built without reinforcing steel. Deteriorated concrete as disclosed by visual inspection, i.e. deep cracks and spalling, will be exposed to rapid deterioration which could eventually lead to the possible collapse of this wall. The integrity of this wall is important to the embankment for the following reasons:

Photo No. 11 - Right training wall of sluiceway.

It is recommended that the owner engage a qualified engineer to design for the necessary repair of the badly

cracked right training wall of the spillway and to evaluate further the potential for overtopping and the inadequacy of the spillway.
